**CORROSION TESTS OF LITHIUM FLUORIDE
IN CONTACT WITH COLUMBIUM ALLOYS**

TOPICAL REPORT II

LITHIUM FLUORIDE BELLOWS CAPSULE TESTS

January 29, 1970

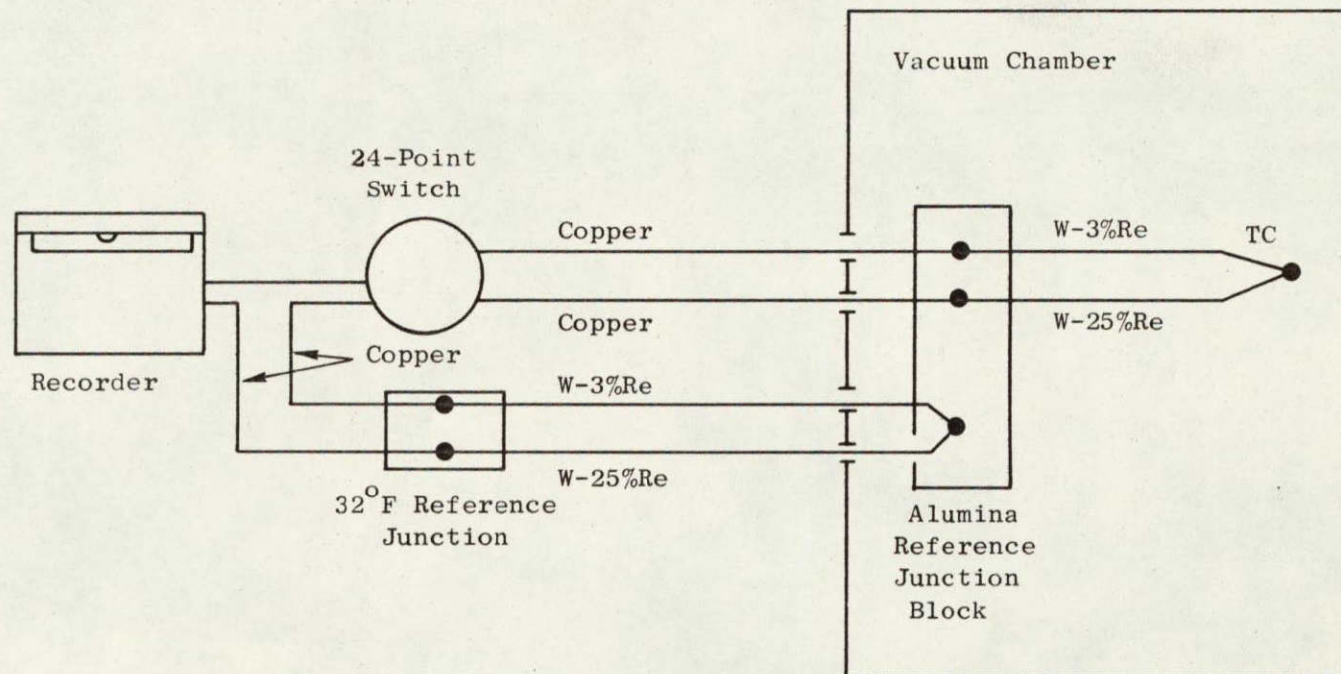
Figure 17. Thermocouple Circuitry Employed in the Lithium Fluoride Bellows Capsule Tests.

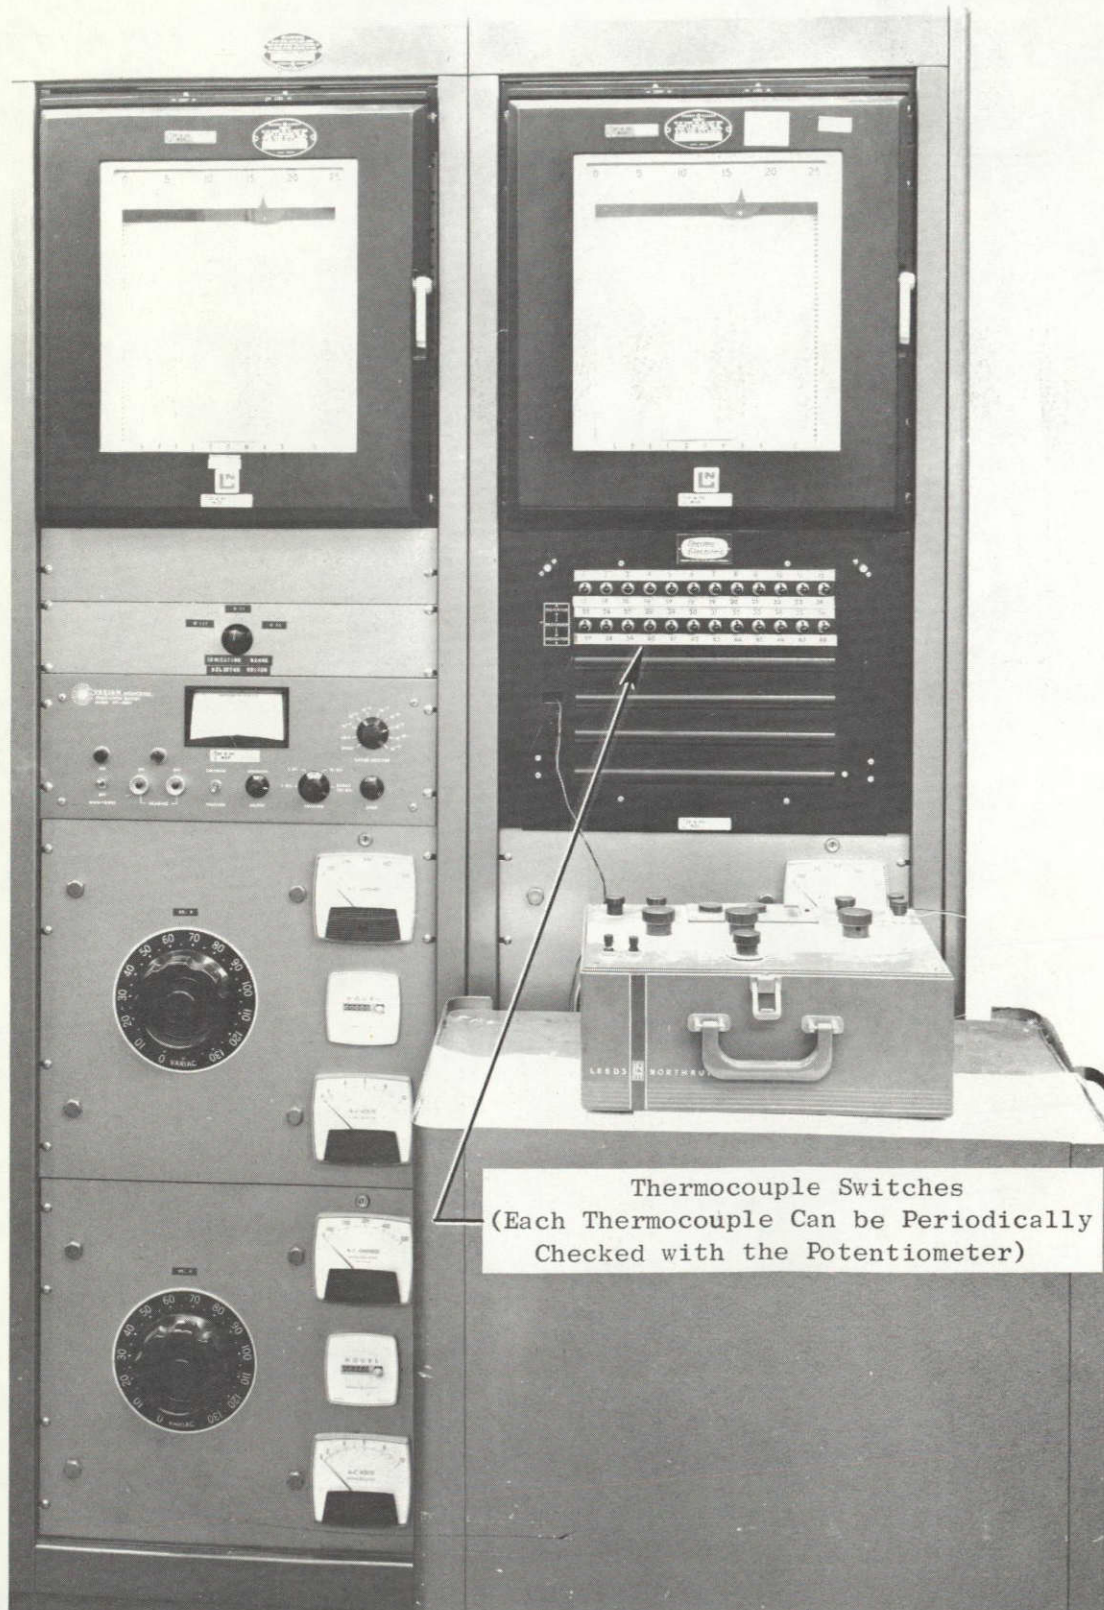
Figure 18. Temperature Measuring and Recording Instrumentation - Lithium Fluoride Bellows Capsule Test. (C67031432)

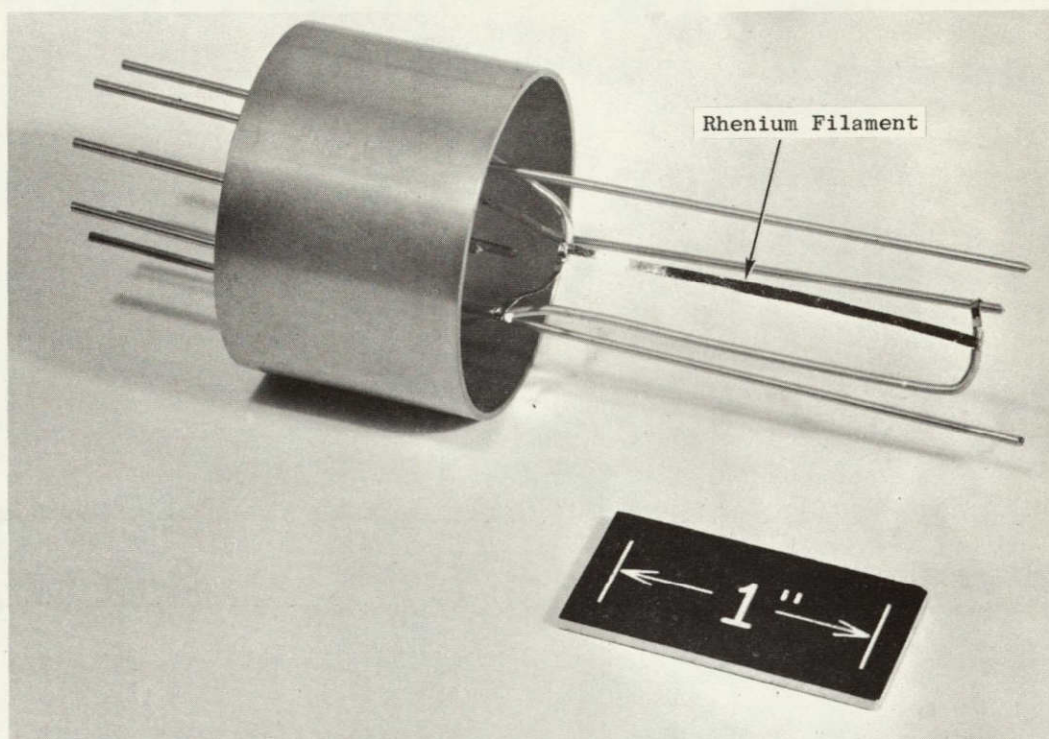
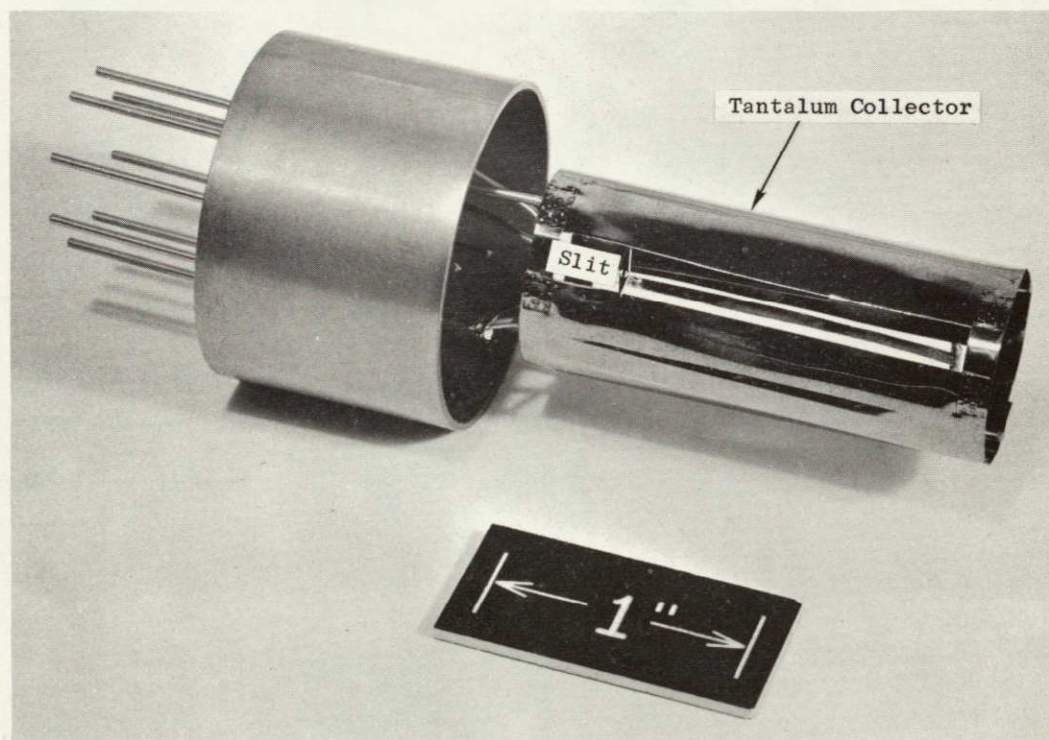
Before Attachment of the Tantalum Collector

Tantalum Collector In Place

Figure 19. Lithium Fluoride Leak Detector Filament and Collector Assembly.
(C6122258 & C66122259)

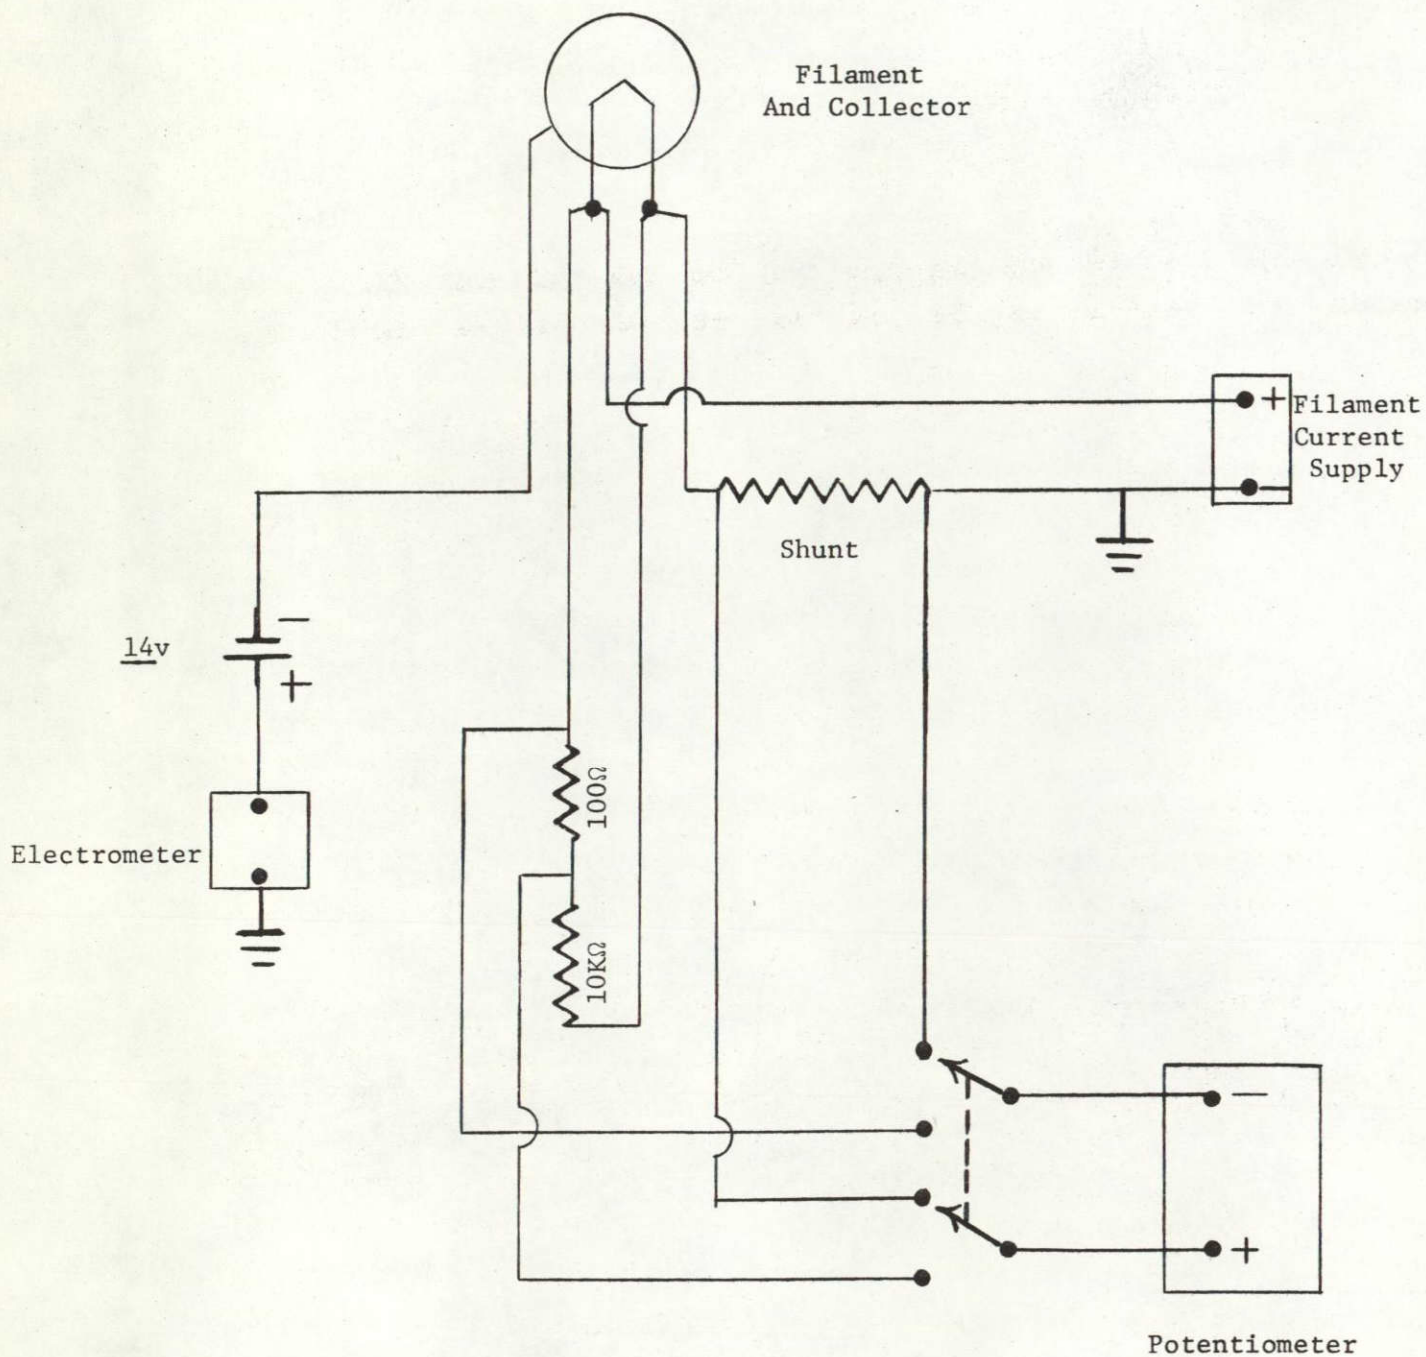
Figure 20. Lithium Fluoride Leak Detector Wiring Schematic Diagram.

Lithium fluoride leak detectors were used on each of the bellows capsule tests. The operation of such a surface ionization detector depends on the conversions of an atom of low ionization potential into a positive ion on a surface with a high work function. The detector shown in Figure 19 employs a rhenium filament and a tantalum collector. Lithium fluoride molecules impinging on the heated rhenium filament will be dissociated to atoms and the lithium atoms subsequently will be ionized. The ionized lithium atoms will be drawn to the tantalum collector which is electrically negative. The electrical signal produced by these ions can be detected with an electrometer, as shown in the wiring schematic, Figure 20.

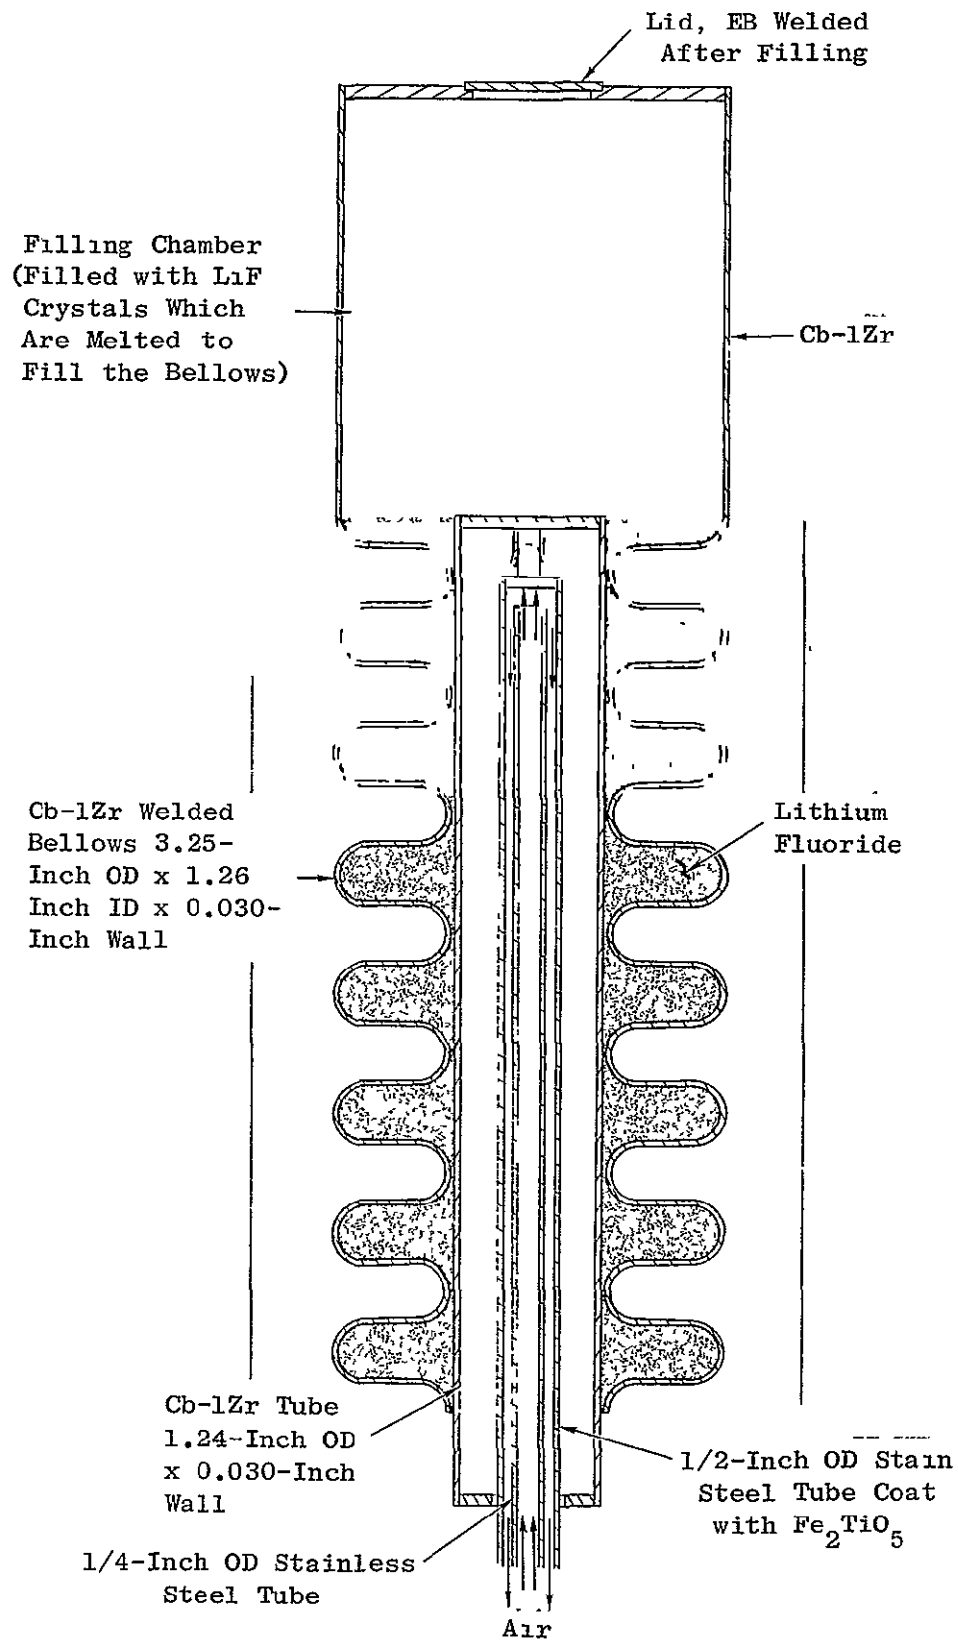
Figure 22. Schematic of Bellows Capsule I Test Facility.

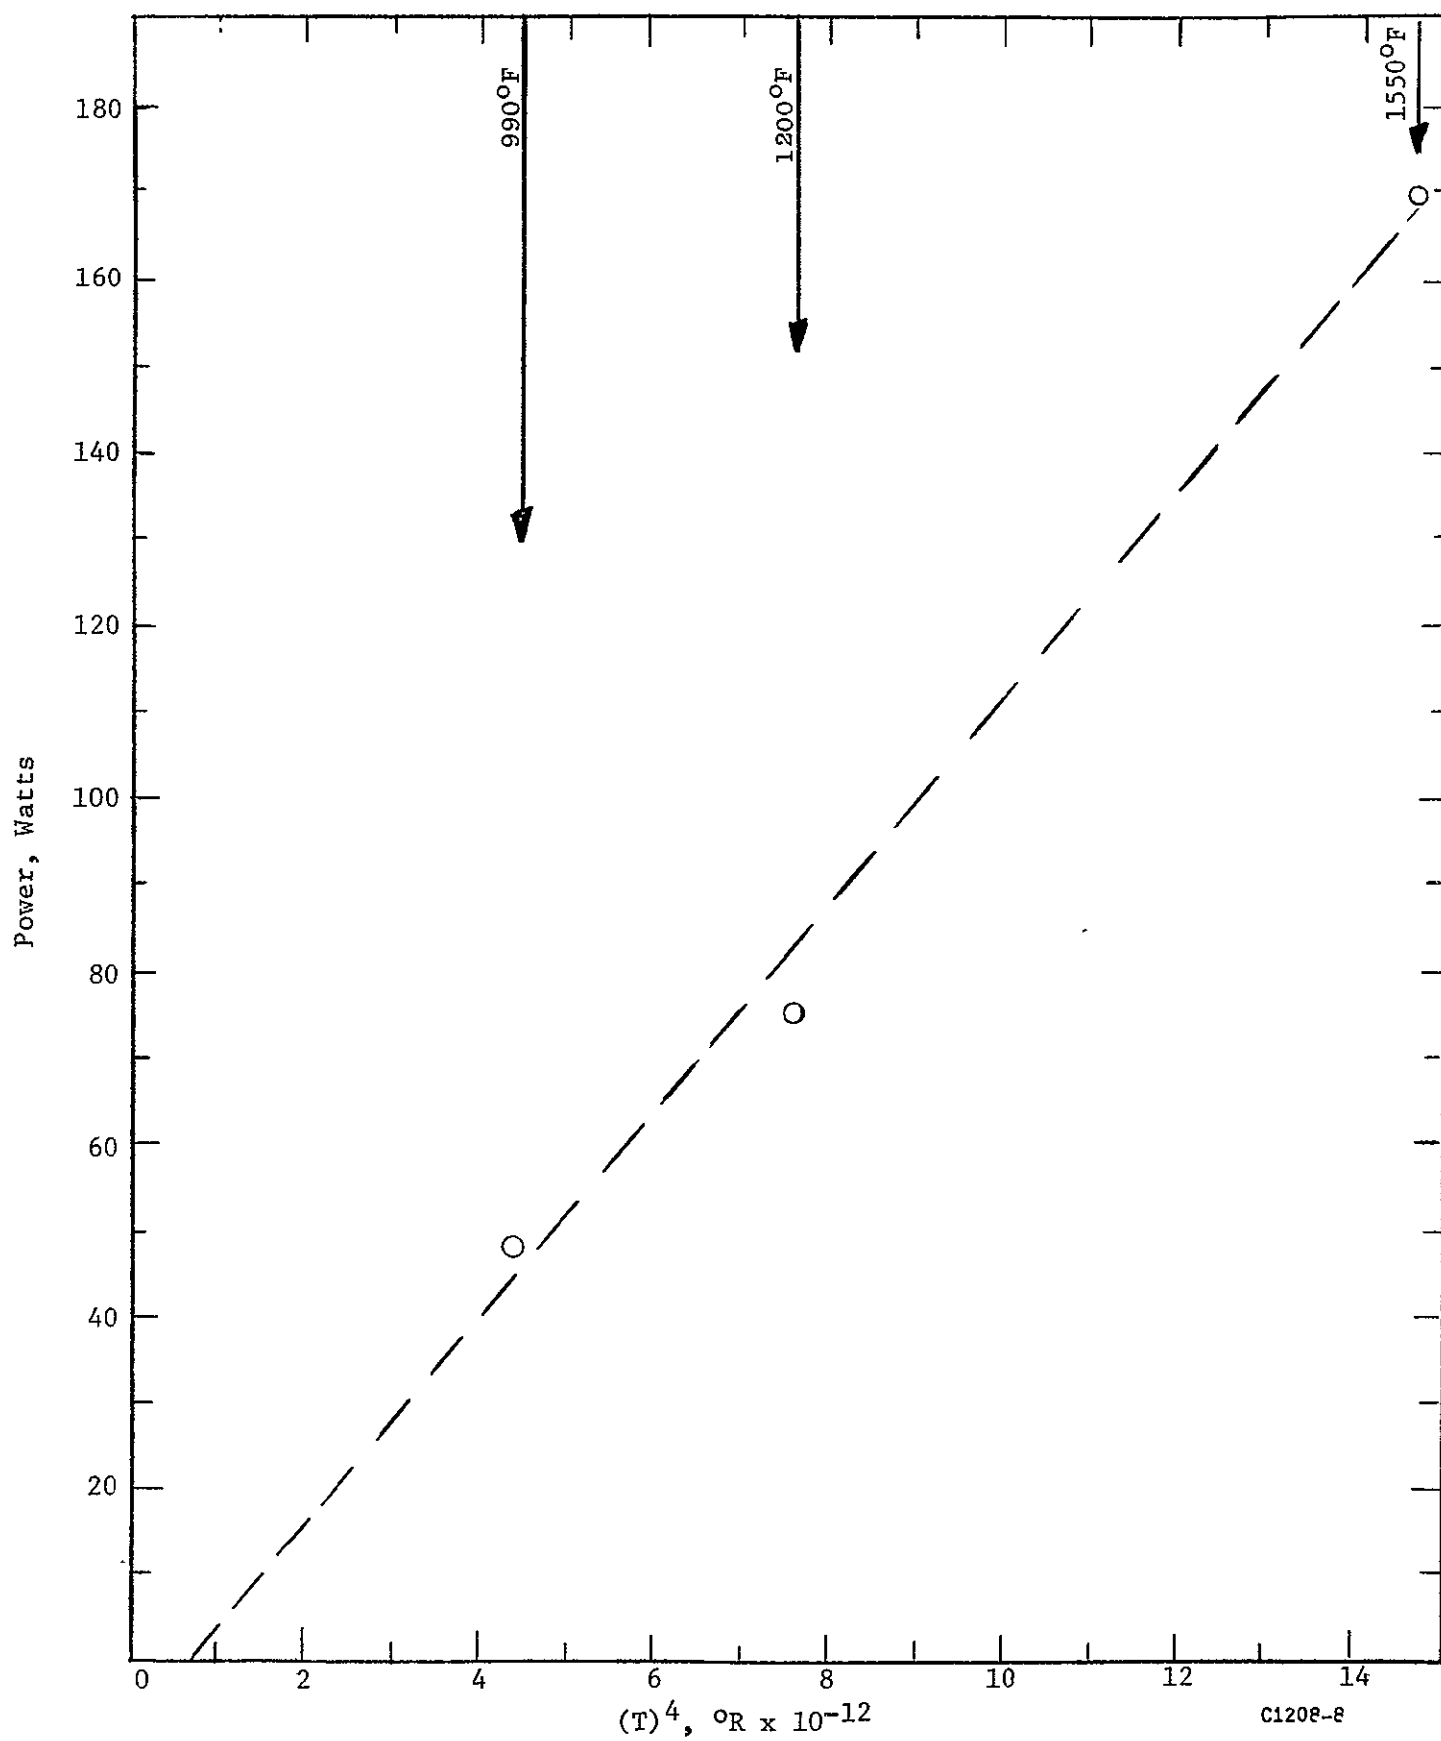
Figure 23. The Steady State Power Temperature Relationship During the Initial Heat-Up of the Lithium Fluoride Bellows Capsule Test. No Air Flowing.

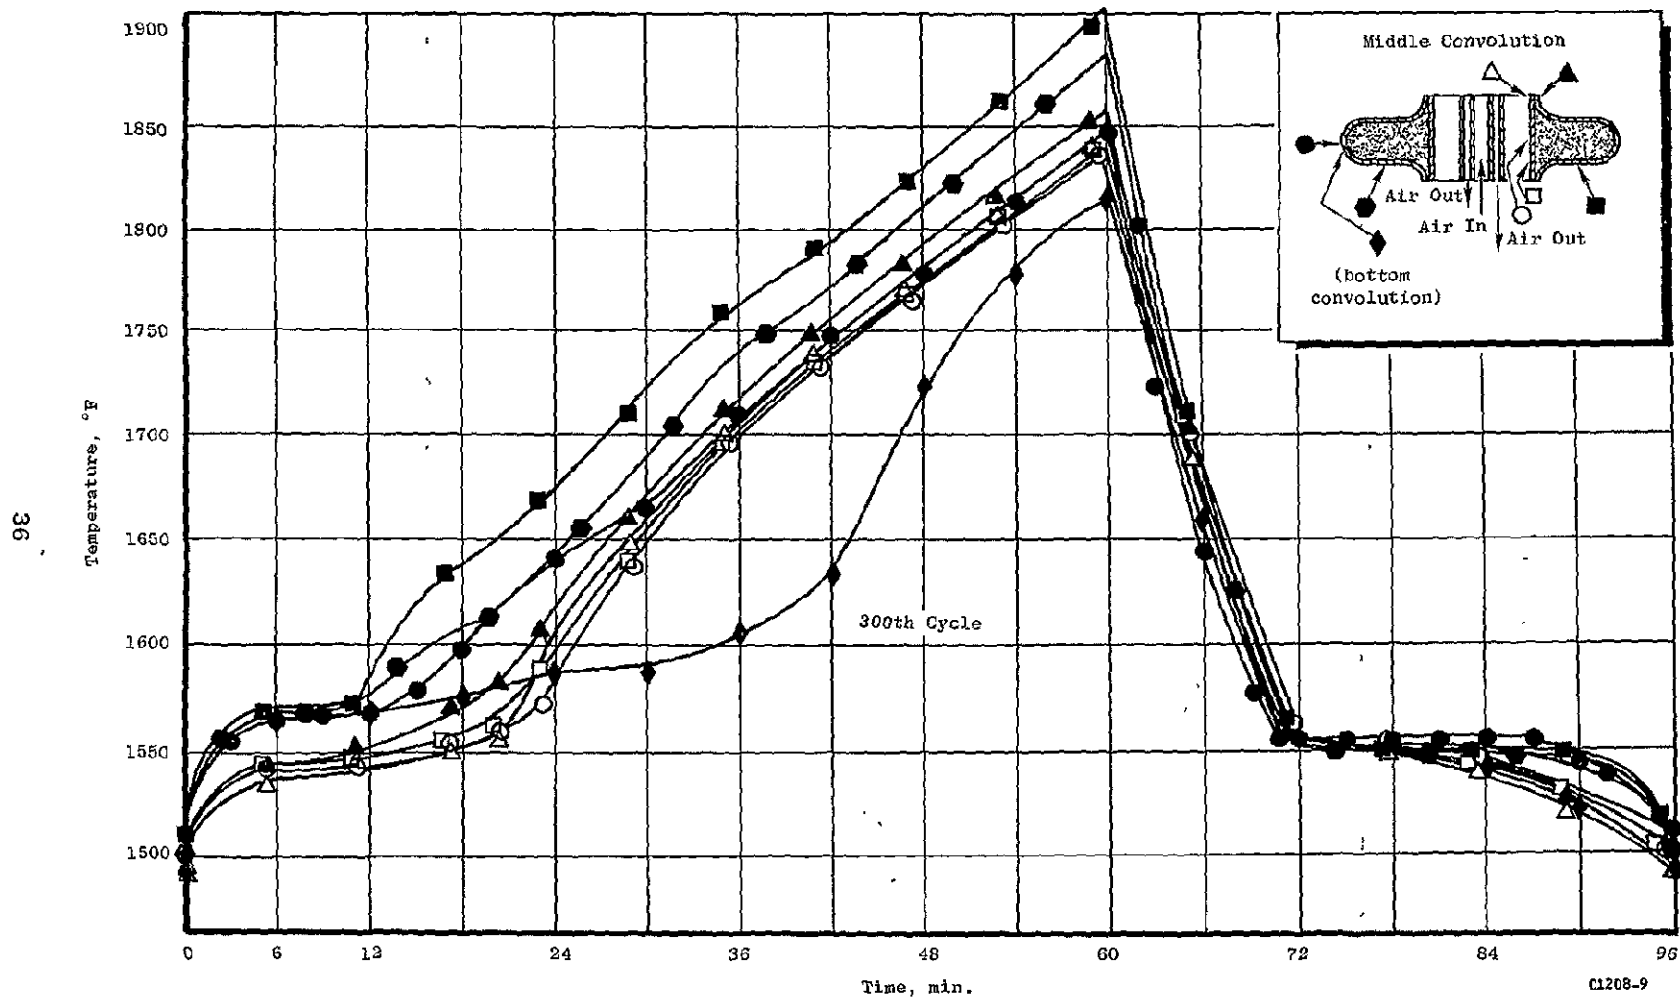
Figure 24. Temperature Profiles on the 300th Cycle of the Lithium Fluoride Bellows Capsule I Test.

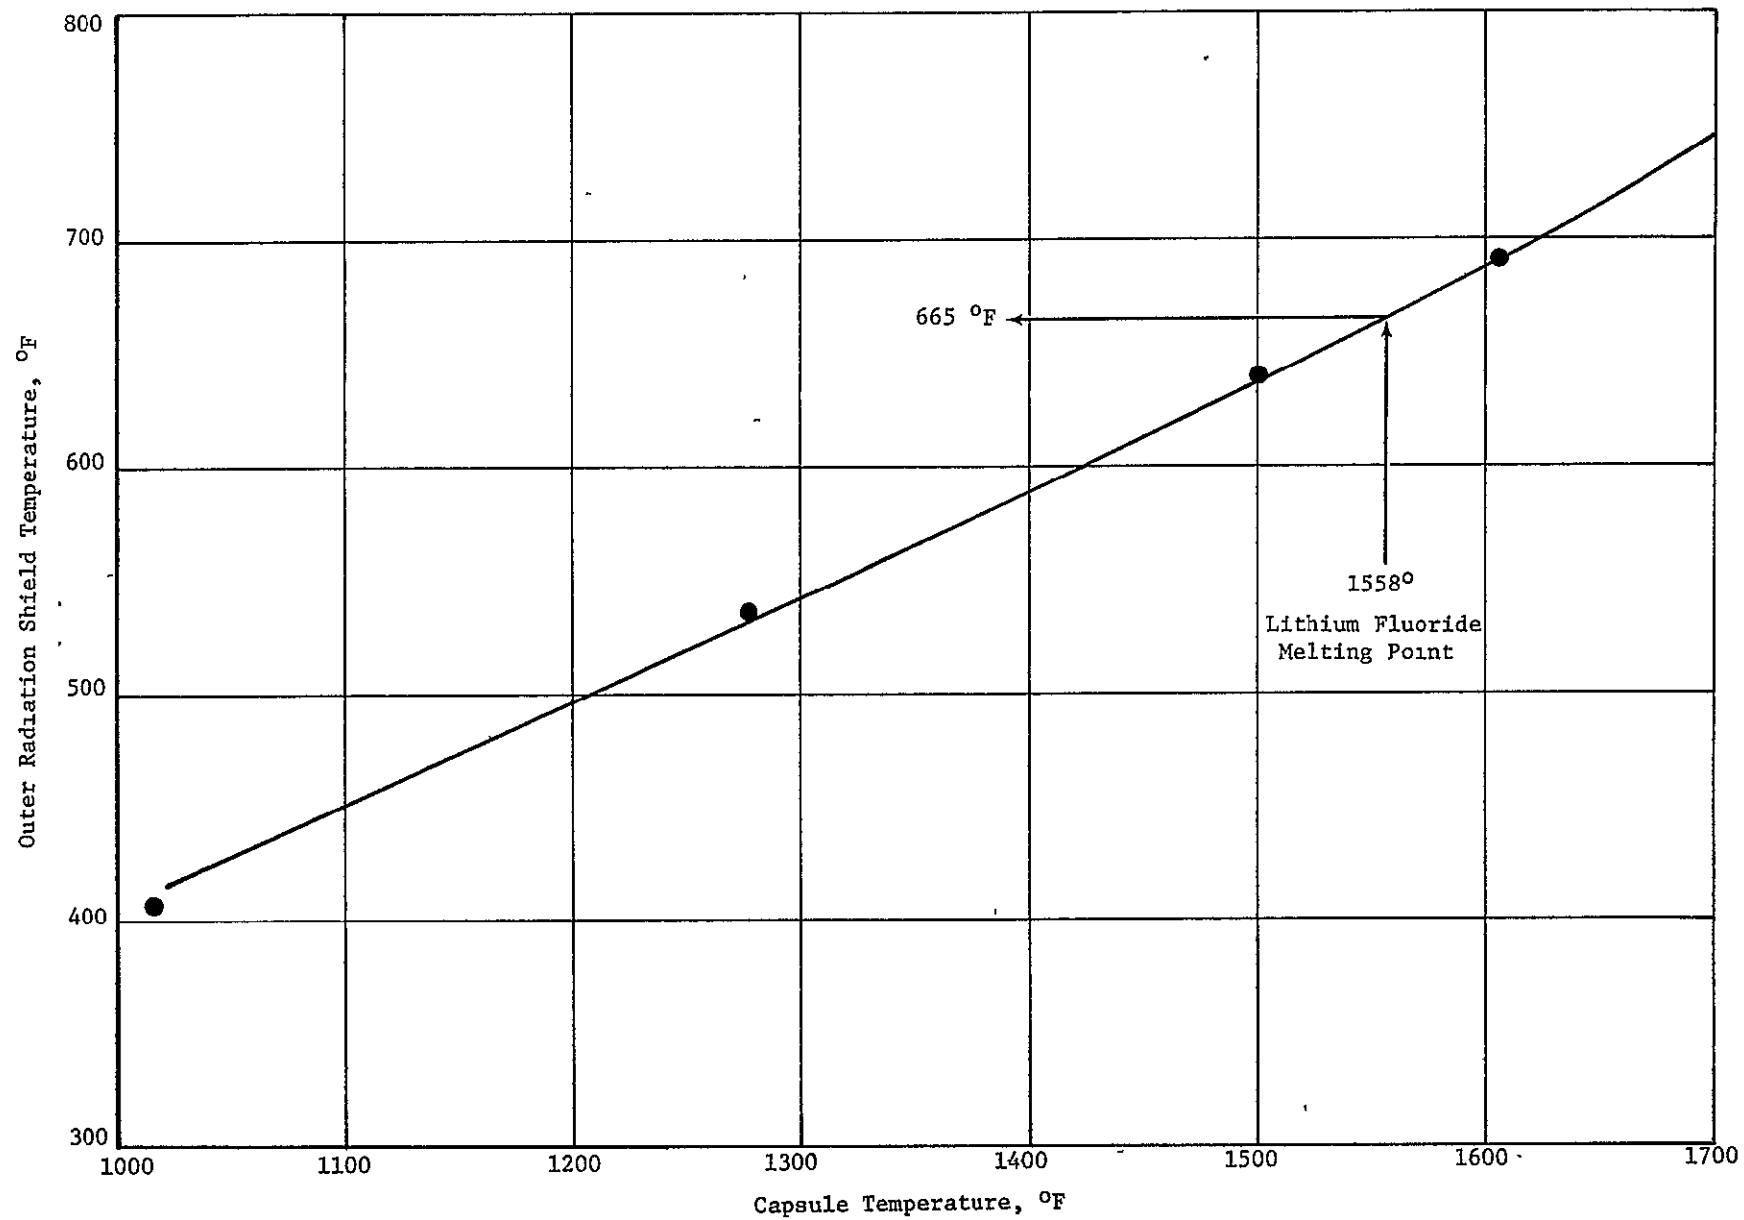
Figure 25. The Steady State Temperature Measurements - Lithium Fluoride Bellows Capsule I Test.

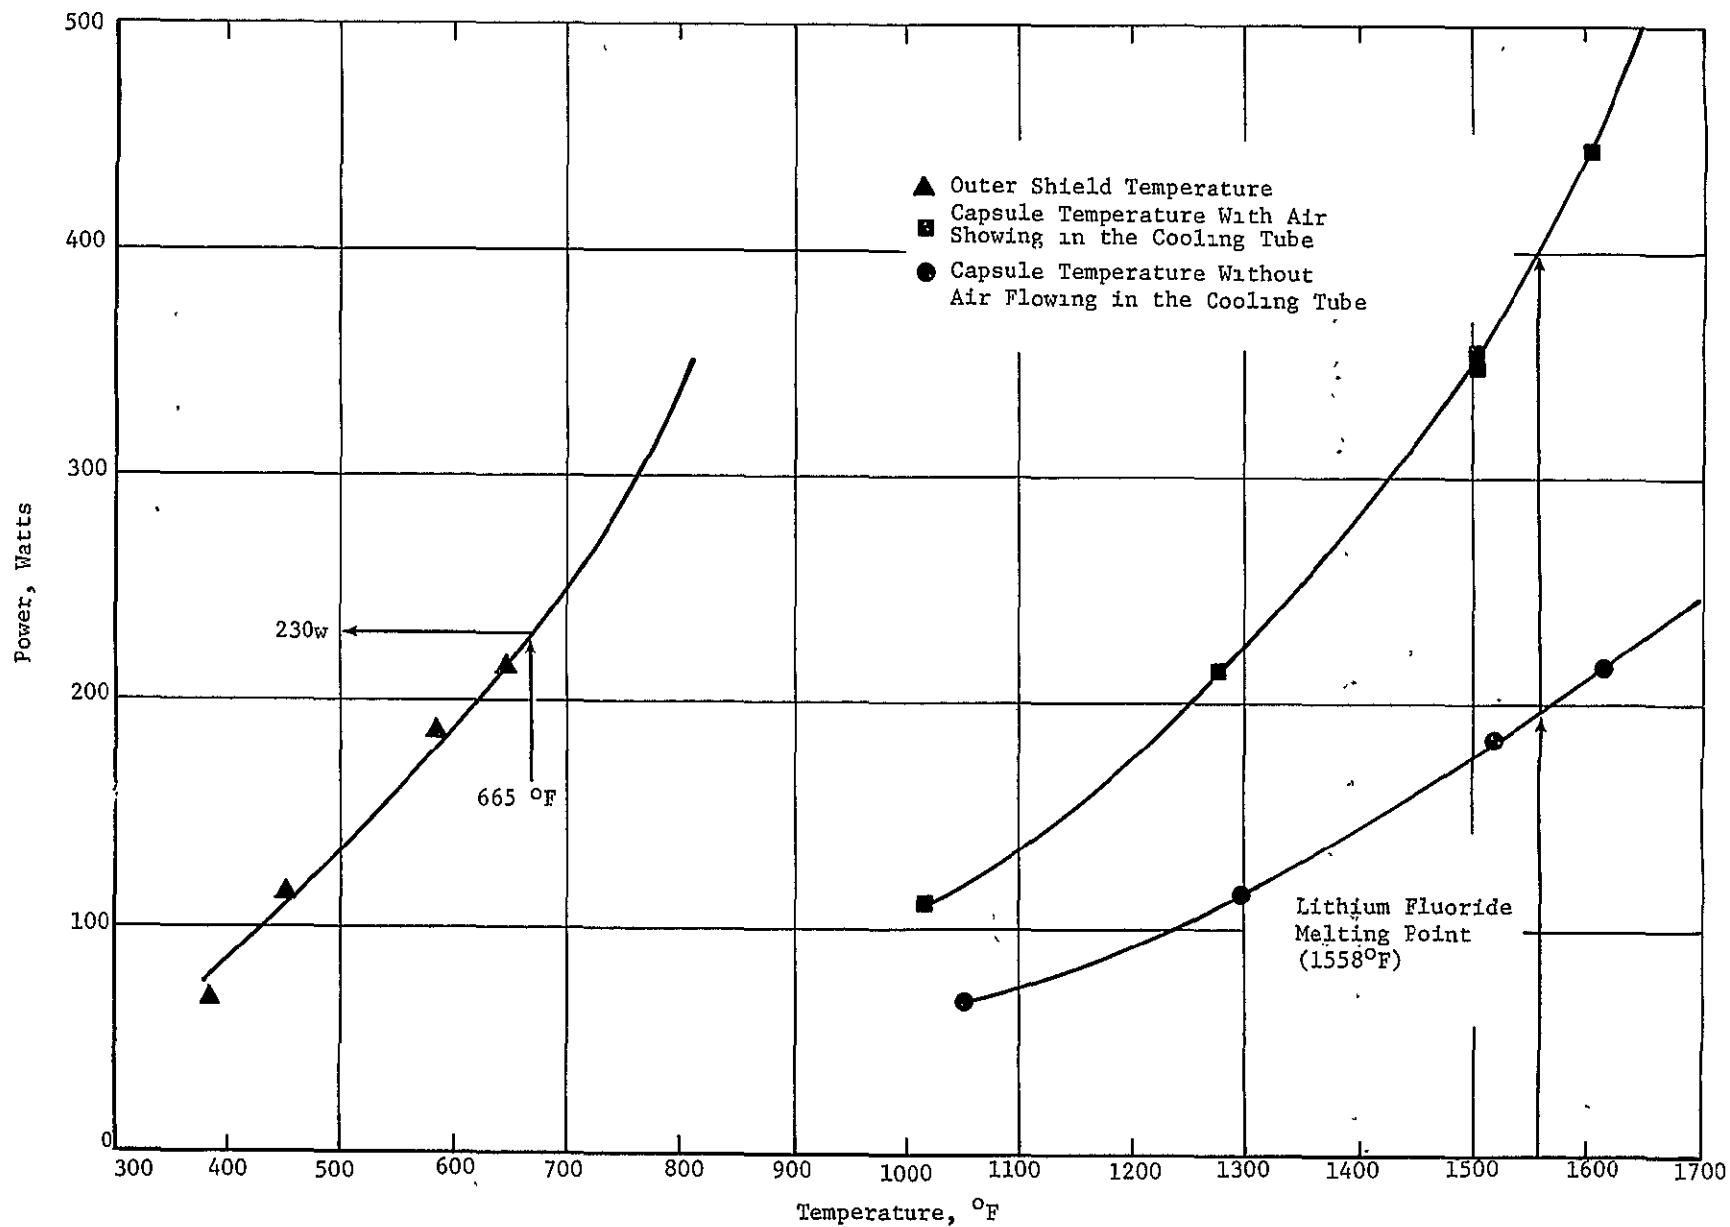
Figure 26. The Steady State Temperature Power Measurements - Lithium Fluoride Bellows Capsule I Test.

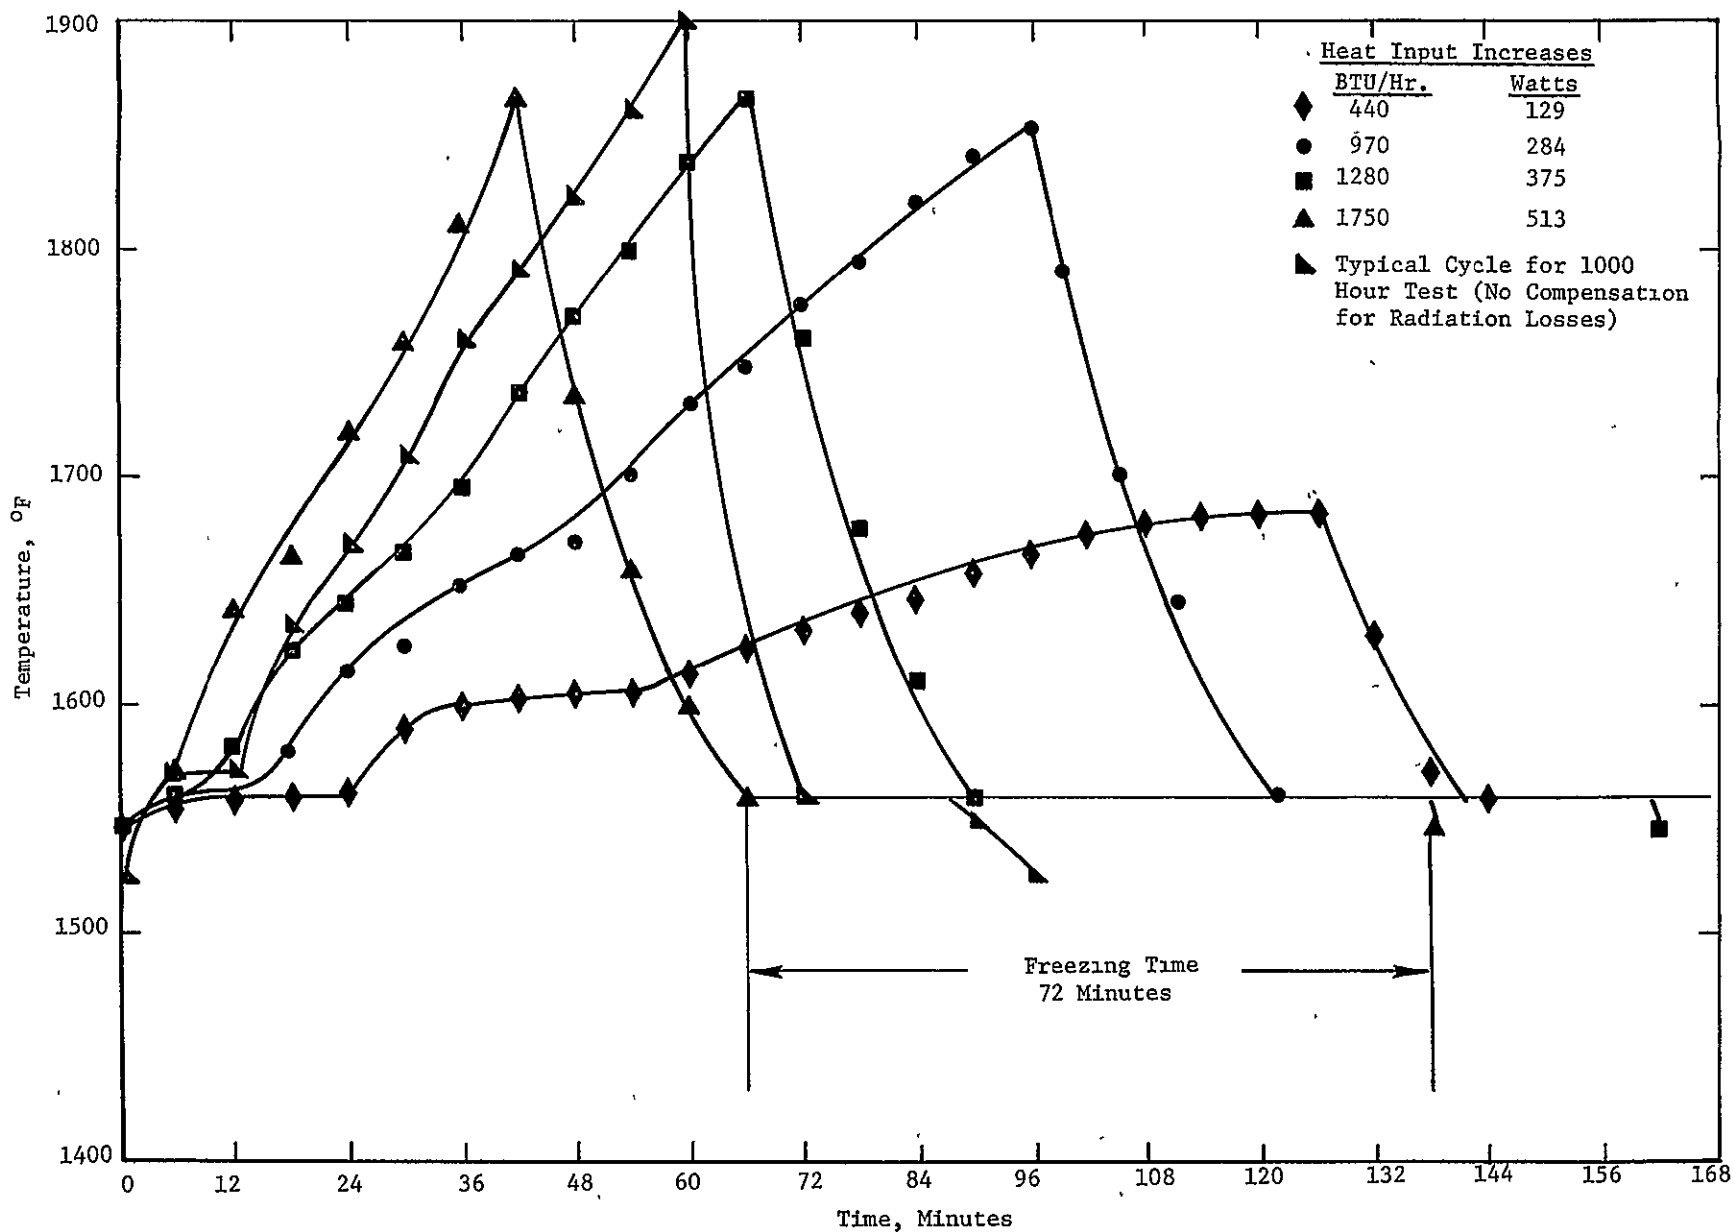
Figure 27. The Heat-up Rates for Various Heat Input Increases Above Steady State Conditions Just Below the Lithium Fluoride Melting Temperature. Radiation Losses are Compensated for on Heating and Cooling.

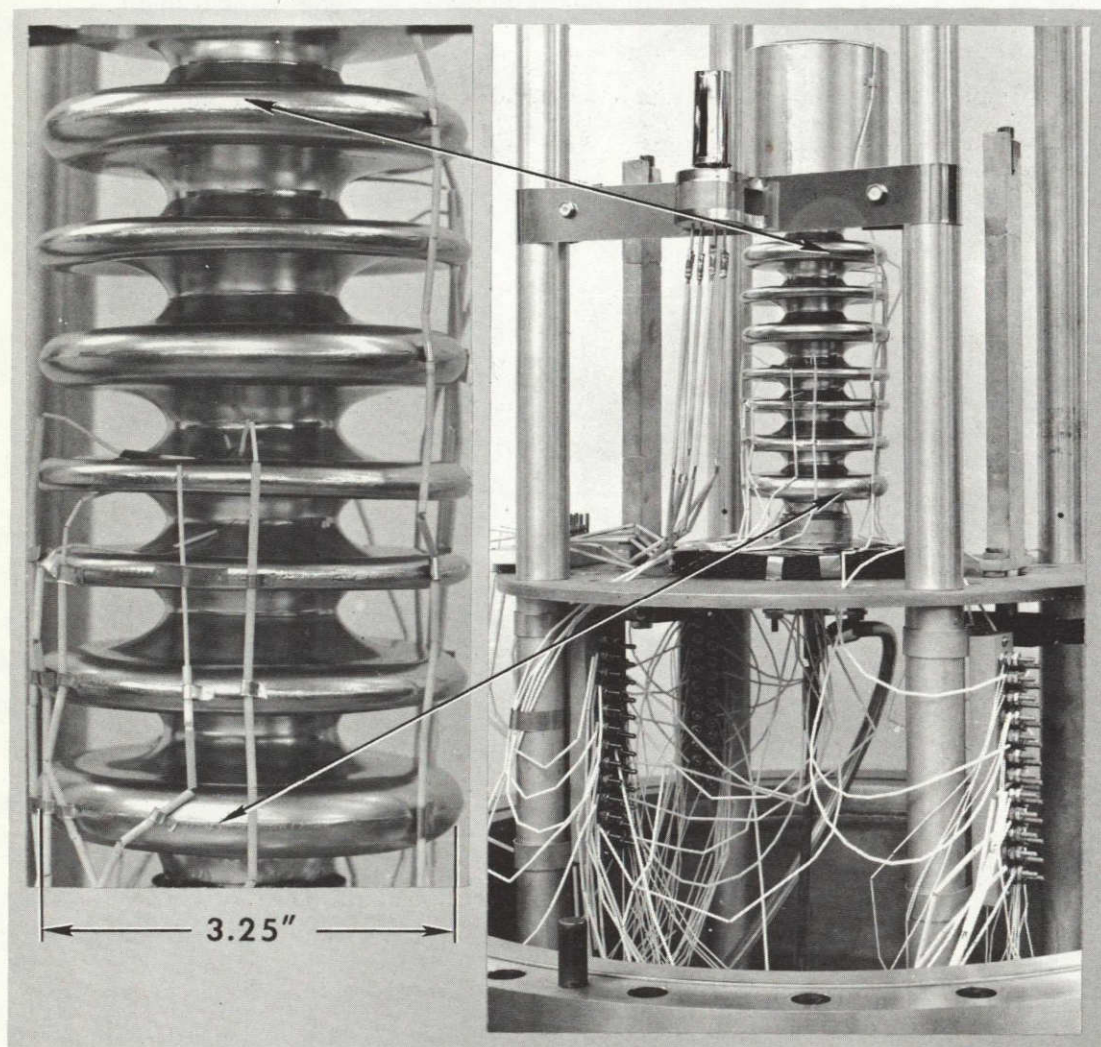
Figure 28. The Lithium Fluoride - Bellows Capsule I After Testing. The Capsule was Cycled 625 Times Between 1520°F and 1900°F in 1000 Hours. (C67041909, C67041910)

After completing these final experiments the bell jar was removed from the test facility. The outer shield assemblies were removed and the capsule was inspected. As can be seen in Figure 28, four of the seven bellows convolutions decreased in thickness (height) during the test. The capsule was removed from the test facility and inspected. The overall capsule height was reduced to 11-1/16 inches as compared to an original height of 12 inches as shown in Figure 29. The cause of the deformation, which is described in detail in the Evaluation Section of this report, is associated with the 1900°F maximum test temperature. As a result the maximum temperature of Bellows Capsule II and III was reduced to 1700°F.

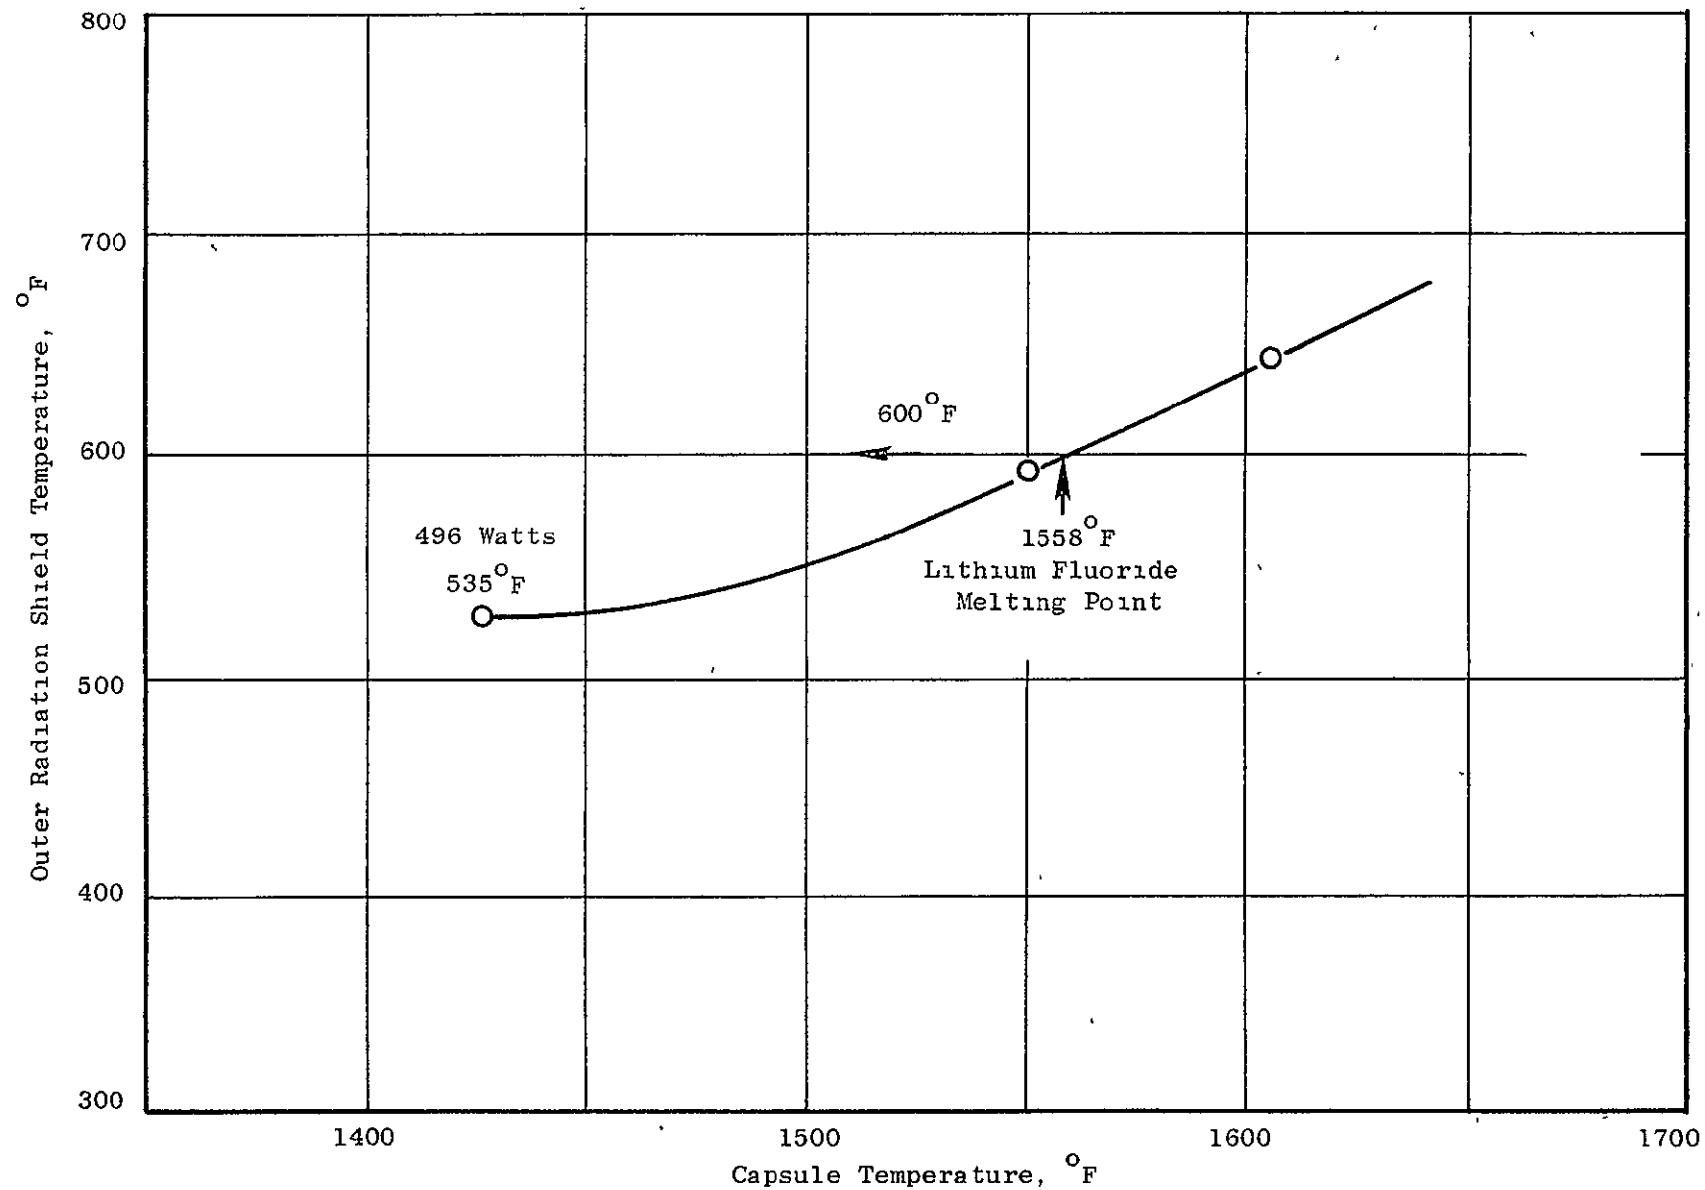
Figure 31. The Steady State Temperature Measurements with 19SCFM Air Flowing in the Cooling Tube - Lithium Fluoride Bellows Capsule Test II.

From the graph of capsule temperature* with air flowing in the cooling tube vs. the outer radiation shield temperature, shown in Figure 31, a shield temperature of 600°F can be found to correspond to a capsule temperature at the melting point of lithium fluoride. From the power-temperature curve for the outer radiation shield, shown in Figure 32, a power value of 250 watts can be found to correspond to an outer shield temperature of 600°F. Neglecting small conduction losses, all the heat loss must occur by radiation when no air is flowing in the cooling tube. The power input, when the capsule is at steady state with no air flowing in the cooling tube, can therefore be equilibrated to radiation loss. Using Figures 31 and 32 it may be concluded that the radiation loss is equivalent to 250 watts when the capsule is at 1558°F. Application of 250 watts to the split tantalum heater during the cooling portion of the cycle compensates for this radiation loss. Under this condition capsule cooling occurs by heat rejection to the center cooling tube, a better simulation of the heat rejection mode in the Solar Brayton Cycle Heat Receiver.
